15 April 2012

Spectra Limited
P.O. Box 613
Dunedin 9054

**RADIO NETWORK BUILDING, 106 GEORGE ST, DUNEDIN
DETAILED SEISMIC ANALYSIS**

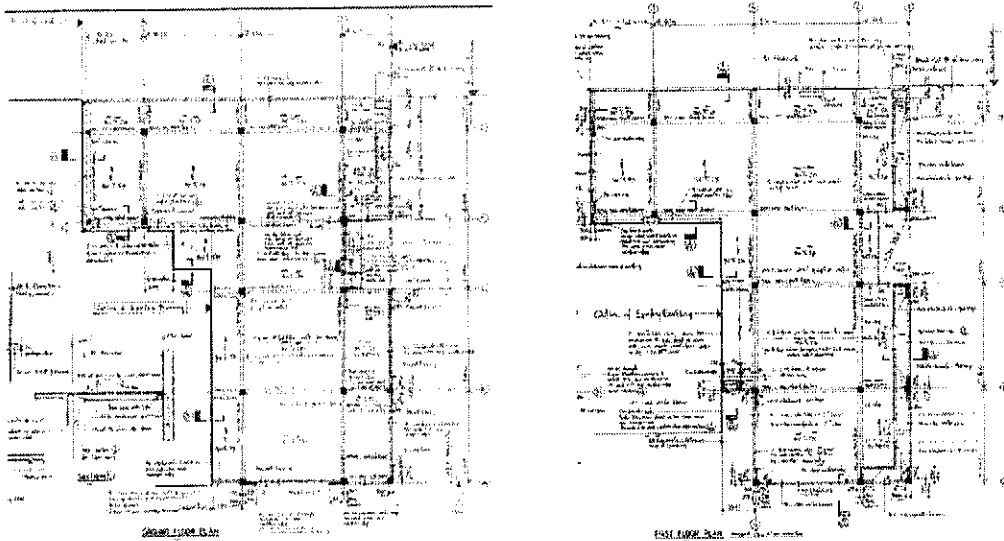
Figure 1: Excerpt from the original construction drawings showing the ground and 1st/2nd floor layout of the building. The offset column can be seen on the ground floor plan at grid 4D. The hole for the separate stairwell structure can be seen on the 1st floor plan between grid points 1C-2D.

3. At grid position 4-D on the plans in the basement a column has been positioned so that it is offset from the columns above it to accommodate an existing pilecap of the 1965 building. A consequence of this is that in addition to the flexural forces in the column imposed by lateral earthquake loading further flexure is imposed by the vertical load from the columns above being applied at an eccentricity from the centre of the lower column. The presence of this column contributed to the IEP %NBS rating that this building achieved on its initial investigation. Detailed analysis of the building has shown that the capacity of the column to resist the combined flexural forces is over 100% of that required to resist full current Standard earthquake loading.
