## 184 HIGH STREET, DUNEDIN – UPDATED DETAILED SEISMIC ANALYSIS

**184 HIGH ST, DUNEDIN**  
**DETAILED SEISMIC ANALYSIS**

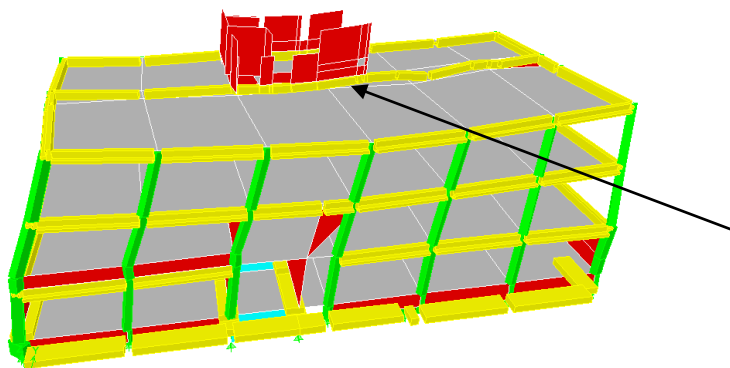
1. The response spectrum analysis has shown that the reinforcing that ties the 2<sup>nd</sup> storey floor into the lift and stair well will start to fail in shear when the building is subject to shaking that is 75% of what the building would be subjected to under current Standard requirements. As the overstressed ties break other ties around the stairwell/lift shaft become more stressed until they also become overstressed and break leaving the floor with fewer ties as shaking continues.

The building gets some of its resistance to lateral forces from the floor diaphragms transferring load. As the building loses its diaphragm connections it becomes less stiff and lateral displacements become greater with continued shaking. The floors are also supported vertically on a 75mm wide rebate on the beams and until the displacements exceed 75mm the floors should remain in place.

**Figure 2: Showing location where floor ties start to fail under 75% current earthquake loading. The roof has been removed from the view for clarity.**

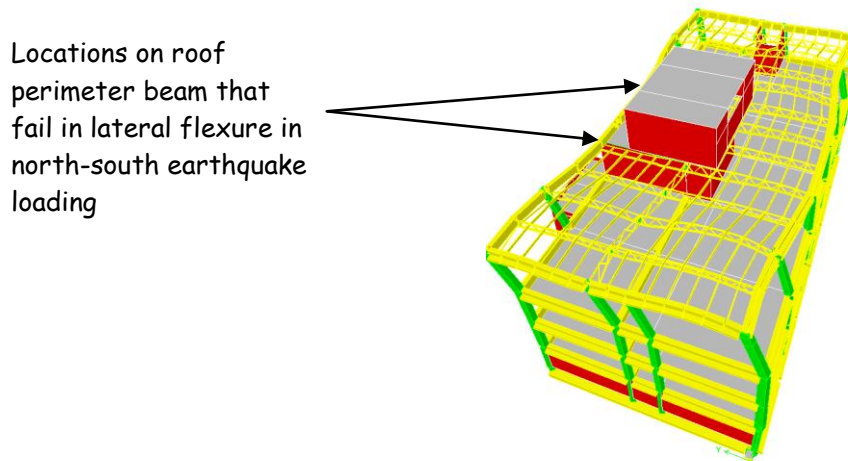
2. Under predominantly north/south direction shaking the ends of the building try to bend around the stiff core like wings. Most of the perimeter beams of the building are tied to the floor diaphragms and are thus restrained to the displacement of the stiff diaphragms. At roof level however the beams do not have a diaphragm to restrain them and are subject to lateral flexure about their weaker axis. The roof perimeter beams are most stressed where they join to the stiff central core as they bend about it. The beams at this location have the capacity to resist up to 80% of the transverse flexural demand of the current earthquake Standard loading.

**Figure 3: Showing building under north-south earthquake loading with exaggerated displacement and sections of perimeter beams which fail in lateral flexure as the building bends about the stiff central core.**
