## 184 HIGH STREET, DUNEDIN – UPDATED DETAILED SEISMIC ANALYSIS

**184 HIGH ST, DUNEDIN**  
**DETAILED SEISMIC ANALYSIS**

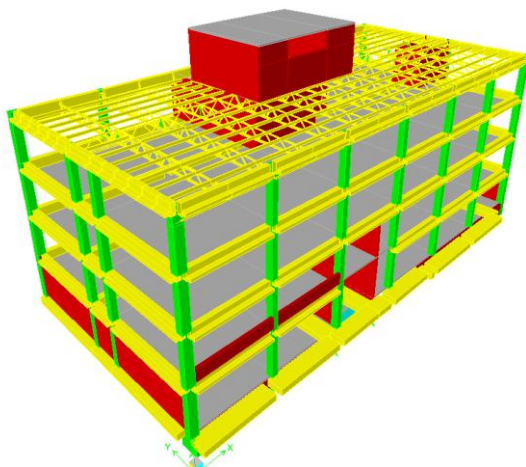
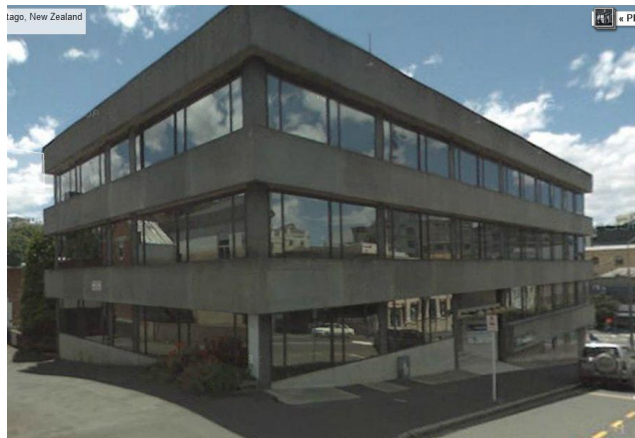
**Figure 1: Showing analysis model of building viewed from the same angle as the accompanying photograph. The concrete perimeter panels at each floor were modelled as inertial weight but are not shown on the model.**

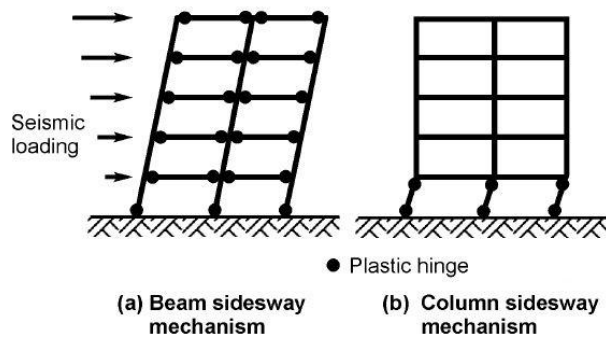
In the diagram below the frame with the beam sidesway mechanism will not collapse with the formation of plastic hinges where they are indicated but the column sidesway mechanism will.

At 184 High St the beams have a lower  $c/d$  ratio than the columns meaning that a beam sidesway mechanism will be likely to form rather than the column mechanism. This means that although members in the building may have failed, collapse is avoided and the occupants are able to escape.

The analysis shows that the beams do have sufficient strength to resist the current earthquake loading (around 150%) and their  $c/d$  ratio is lower than most of the columns which all have a  $c/d$  ratio greater than 1.9, ie 190% NBS.
